ARMY RESEARCH LABORATORY

Investigation of Surface Intergranular Attack and Its Effects on the Fatigue Properties of AM355 Stainless Steel

ARL-TR-1238

November 1996

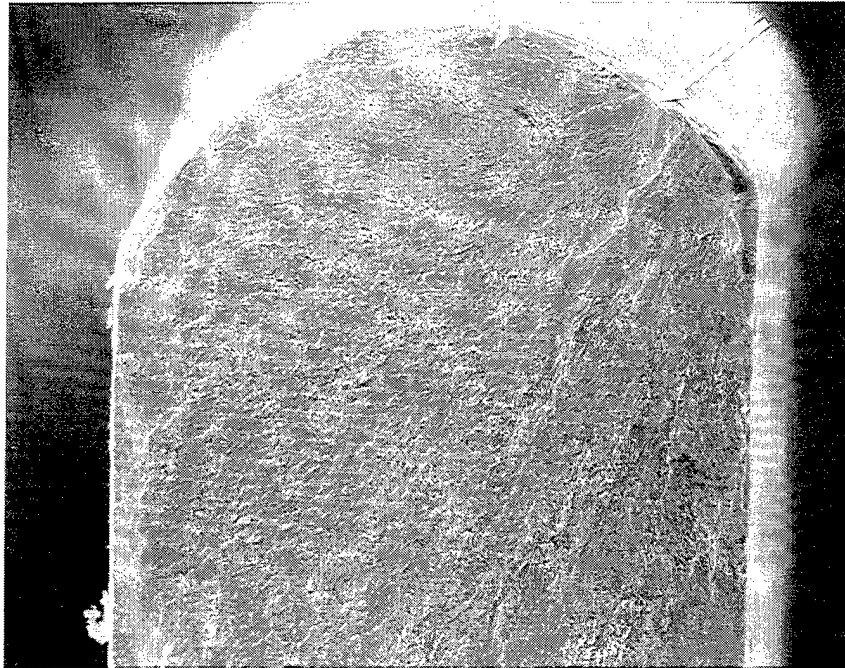
Figure 1. SEM fractograph of 11L from SP #7888 showing an edge origin. Mag. 250 \times .

Scanning electron microscopy was used to determine the exact nature of failure and location of the fatigue origin(s). The specimens failed predominantly from edge defects. The edge finishing performed on the specimens allowed for scratches perpendicular to the specimen length. For the specimens that failed from the edge, these scratches were the origin of fracture, as expected. Figure 1 shows specimen 11L from Strap Pack #7888 with an edge fracture origin (arrow denotes origin). Further investigation revealed scratches on the edge as a result of the finishing procedure, as shown in Figure 2. Upon closer examination, it was observed that the root of a scratch on the edge of the specimen was the origin of fracture. The origin is depicted at higher magnification in Figure 3. Specimens from Strap Pack #7888 did not display any intergranular attack of the surface, and consequently, the edge of the fatigue specimen did not contain any intergranular morphology along its edges. The surface edge of specimen #7888 11L can be observed in Figure 4.

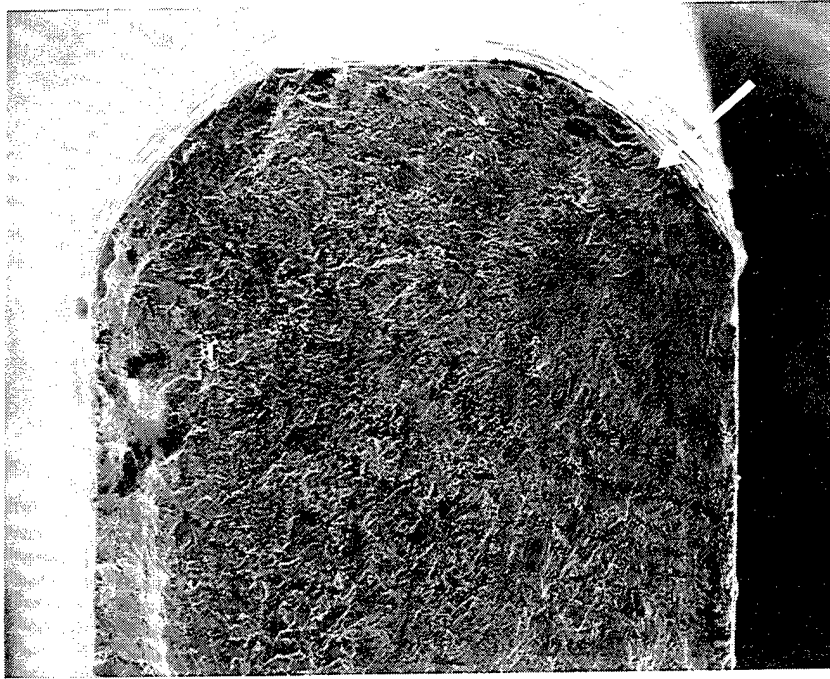
Figure 9. SEM fractograph of Trial R12 showing an edge origin. Mag. 250×

Figure 9 shows the edge failure of "Trial" Strap Pack specimen R12 (arrow denotes origin). This edge failure was caused by surface scratches induced during the edge finishing process, shown in Figure 10 and at higher magnification in Figure 11. However, the "Trial" strap-pack laminates contained characteristics near the surface not witnessed on the strap packs that had experienced prior service (#7888 and #6800). The intergranular attack of the surface of these specimens (categorized as moderate attack) allowed the fatigue crack front to progress along an intergranular network near the surface. Figure 12 shows the fatigue crack following the intergranular network near the surface of the specimens (arrows denote intergranular morphology along edges).
